Keshet Israel Congregation

Keshet Israel 2013-2014 Capital Campaign **Phase I Repair Update**

Phase I of the work started in March 2013, focusing primarily on issues related to external structural deficiencies of each building. Below is a full report on Phase I repairs across all three shul properties.

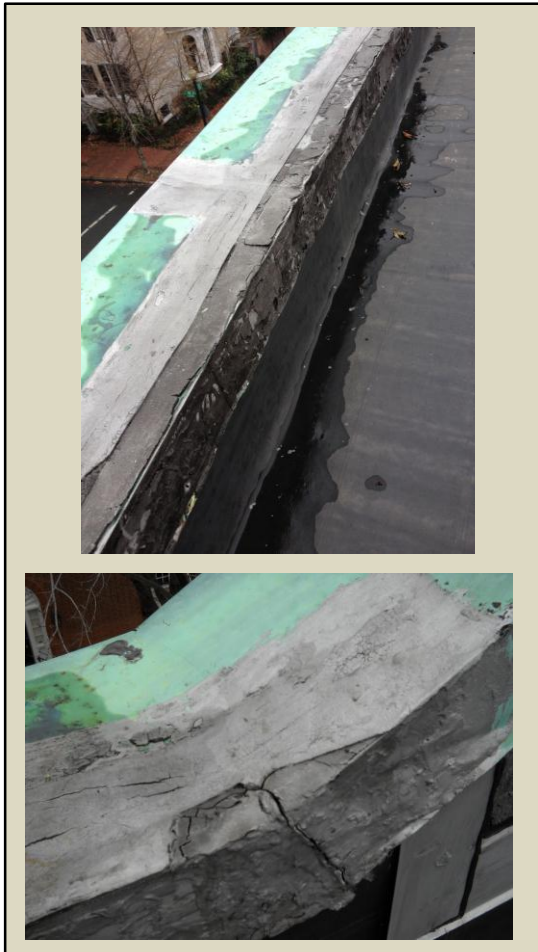
Copper Cap- Before

Roof: Moisture had been seeping into the walls of the main sanctuary, because the copper cap on the top of the exterior wall had been poorly maintained over time. To repair holes, over the years tar or roofing sealant was used but that was only a temporary fix and did not get to the root of the actual problem. So, a new aluminum cap was installed.

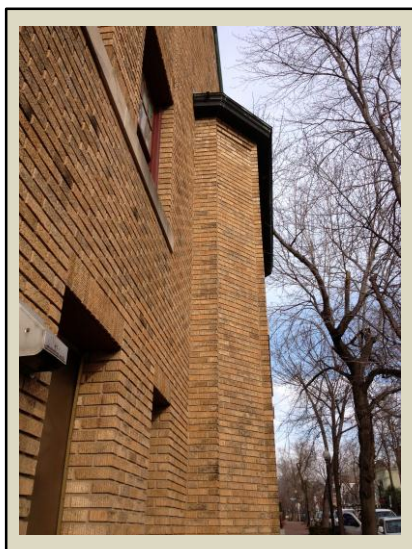
Downspout- Before

Gutters: The gutter surrounding the alcove for the *aron hakodesh* on 28th Street was not draining as it should, which caused water penetration into the walls of the shul. **The gutters were therefore cleaned and a new downspout was added to the side of the building on 28th Street to aid in draining water off the roof.**

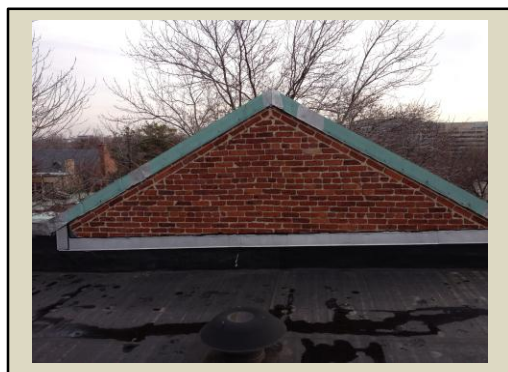
Masonry Gable- Before

Masonry Gables: The brick work on the roof gable (A-shaped roof framing) needed to be re-pointed and waterproofed.

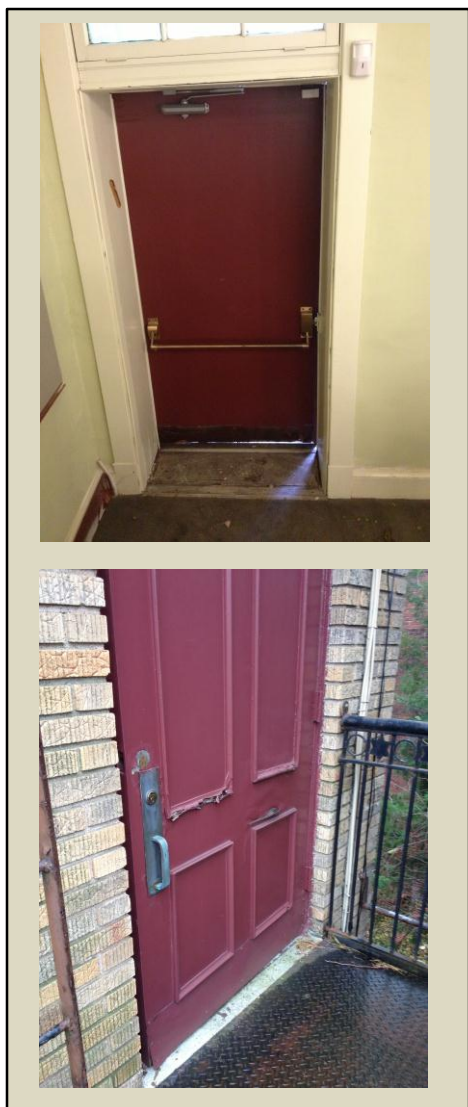
Doors- Before

Back Doors: The original doors and frames at the rear exits of the shul building (all three levels) were made of wood, which have deteriorated over the years. The doors did not close securely, allowing for drafts and posing a security vulnerability. The new doors and frames are made of hollow metal, which is more secure, properly sealed, and better suited for the shul. **By replacing the doors, and the hardware for opening/closing, the doors are now 100% functional and will keep the shul building more secure.**

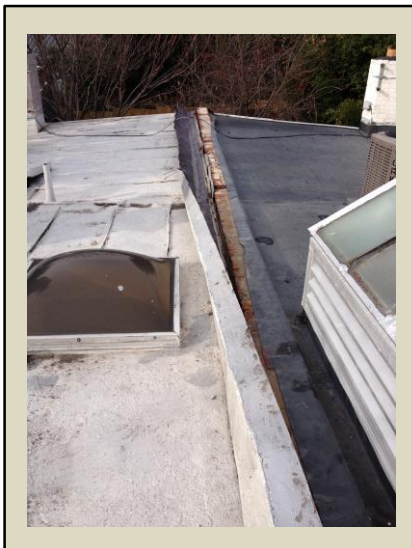
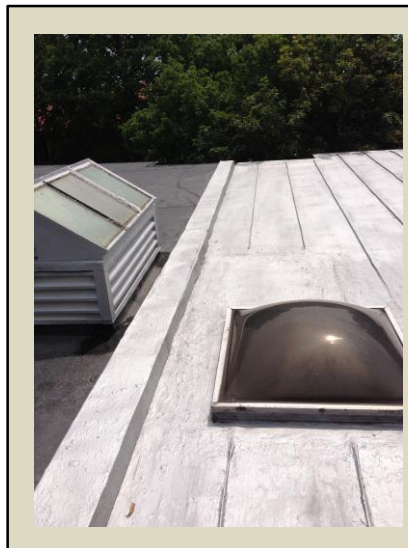
Roof: The aluminum cap was not properly fastened onto the roof, causing water damage on the interior of the Bayit. **The cap was fixed and fastened appropriately.**

Roof- Before

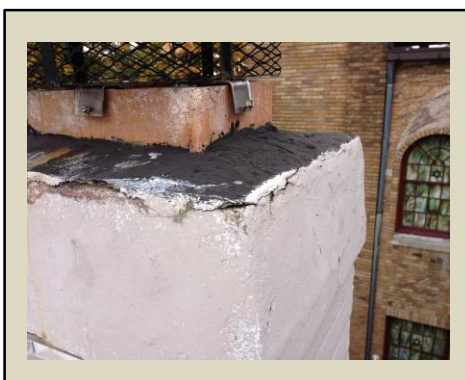
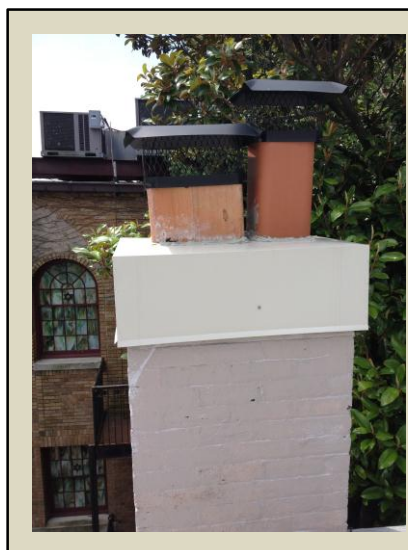
Chimney: The Bayit has two chimneys and one of them was uncapped. Uncapped chimneys allow rain water to enter the home and cause severe water damage. In addition, both chimneys needed to be repainted and waterproofed to prevent additional internal water damage.

Chimney- Before

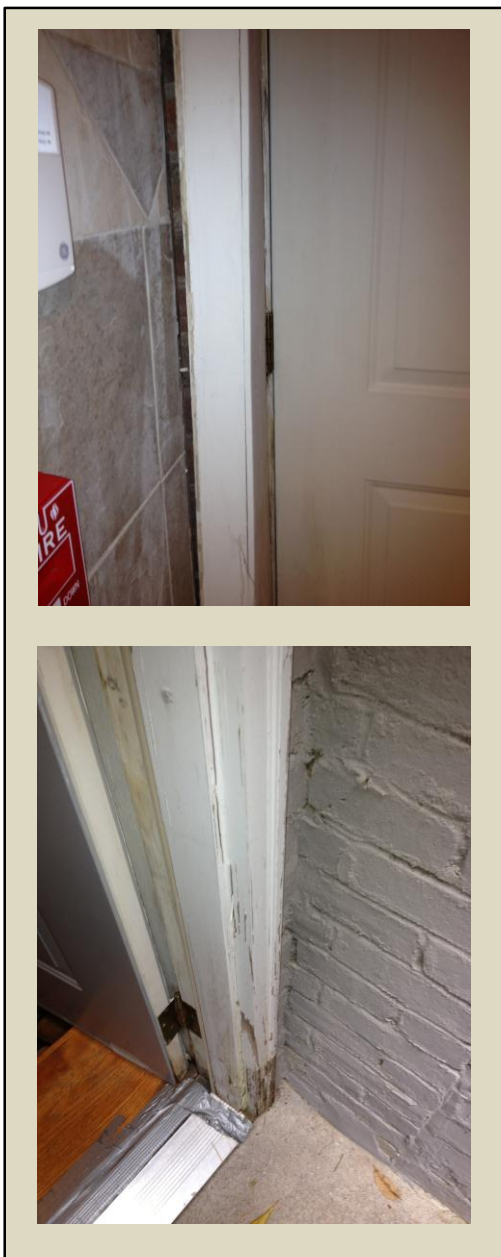
Basement Entry Door- Before

Basement Entry Door: the door to the basement/mikvah was not installed properly, resulting in water penetration around the frame and leakage into the mikvah. **The door was completely replaced and a new frame was installed as well.**
